Memorandum

Subject: *Investigation Summary – OU5 Re-development Area*

CDM Federal Programs Corporation (CDM) was tasked with performing investigation activities within a designated area on the former Stimson Lumber Company site, OU5, to support future re-development activities. The investigation consisted of collecting soil samples for Libby amphibole (LA) asbestos analysis, performing inspections for vermiculite, and delineating areas with LA contamination and/or vermiculite for subsequent removal activities.

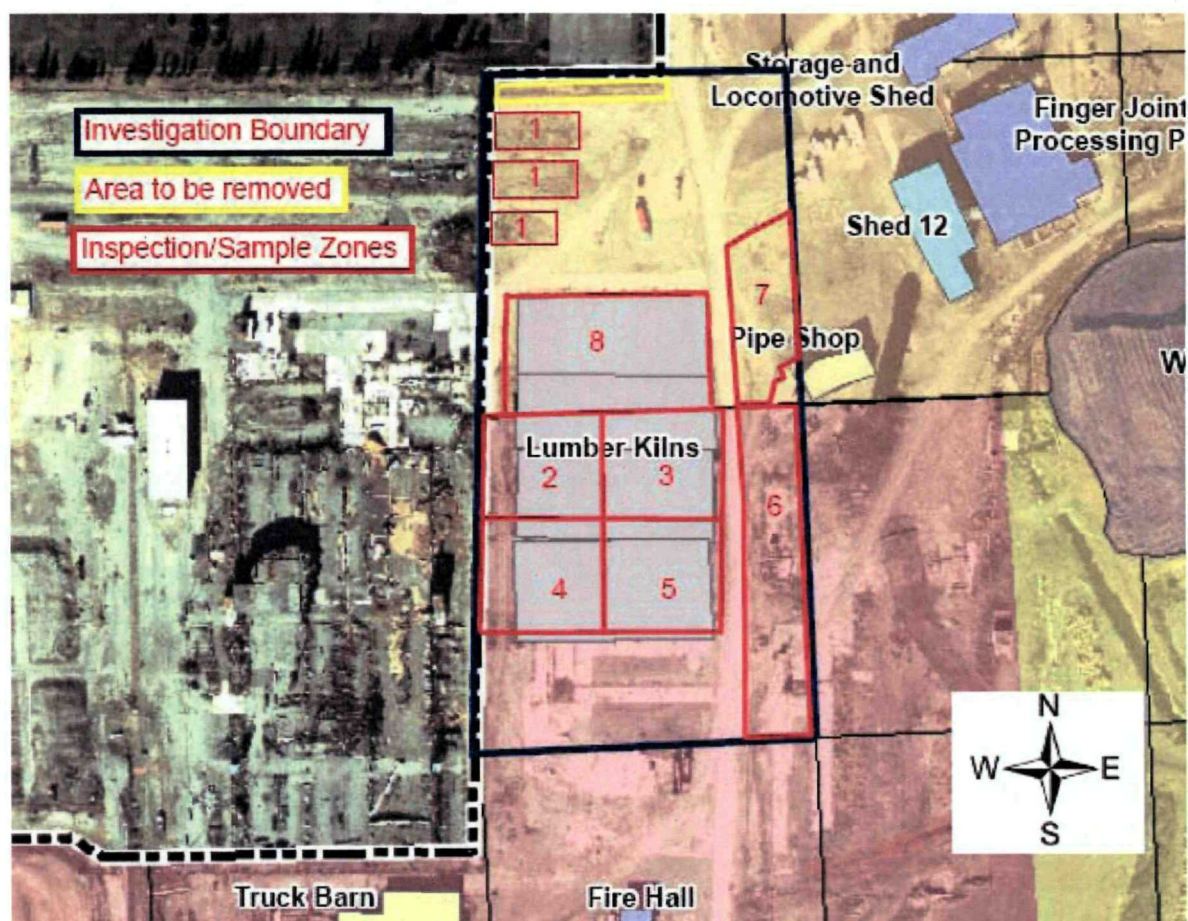
Figure 1

Eight sampling zones were established, sampled, and inspected in accordance with the technical memorandum (Figure 1). Only soil/gravel areas within the identified zones were sampled and inspected. Areas covered with concrete or pavement were not included as part of this inspection. Figure 2 illustrates the detail of each sampling zone and location of vermiculite observed. Copies of logbook entries, field sample data sheets, and visual vermiculite estimation forms are included in Attachment A.

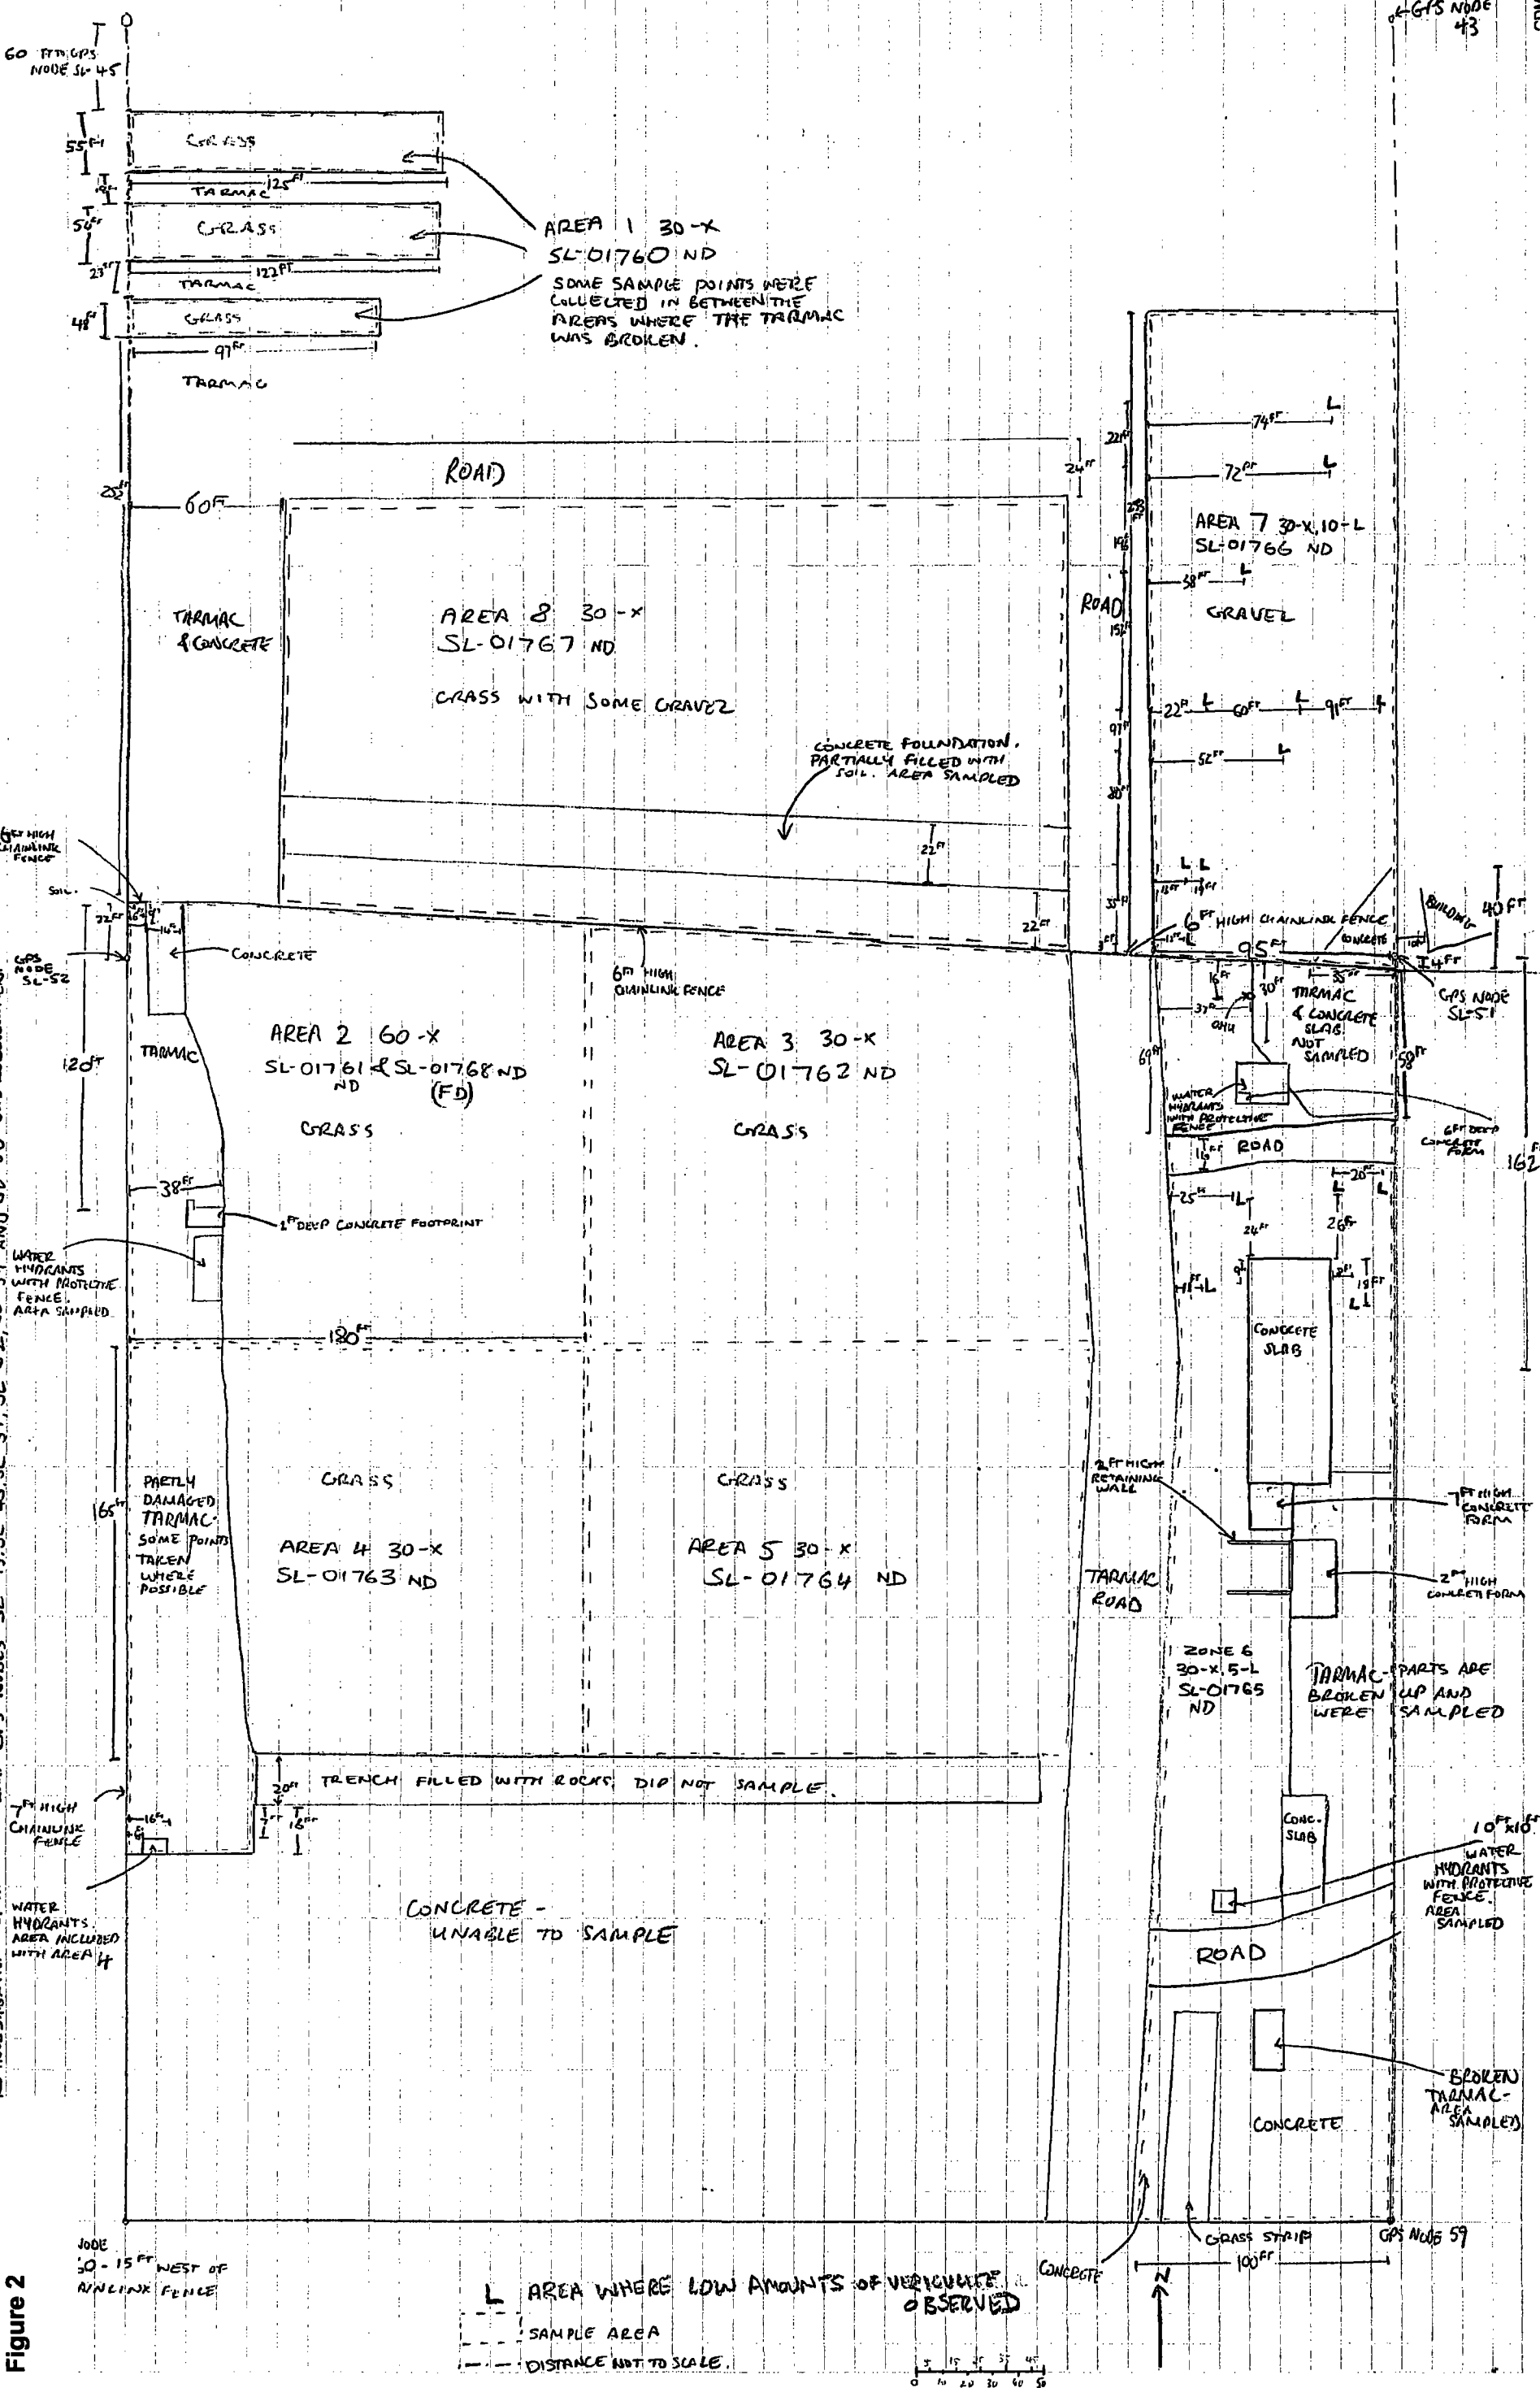
Figure 2

concentrated within a specific area between the north road and concrete slab (Figure 2). Within zone seven, vermiculite was observed widespread throughout the entire zone. The following table summarizes the analytical and vermiculite inspection results for each sampling zone:

CLIENT VOLPE
PROJECT LIBBY ASBESTOS
DETAIL 875 HWY 2 S - STANSON
COMPUTED BY S. WILSON
DATE 4-22-09
PAGE NO. 1
JOB NO. _____
DATE CHECKED BY _____
CHECKED BY _____
RE-INVESTIGATION OF AREAS AROUND GPS NODES SL-43, SL-45, SL-51, SL-52, SL-59 AND SL-60 - OUS REDEVELOPMENT

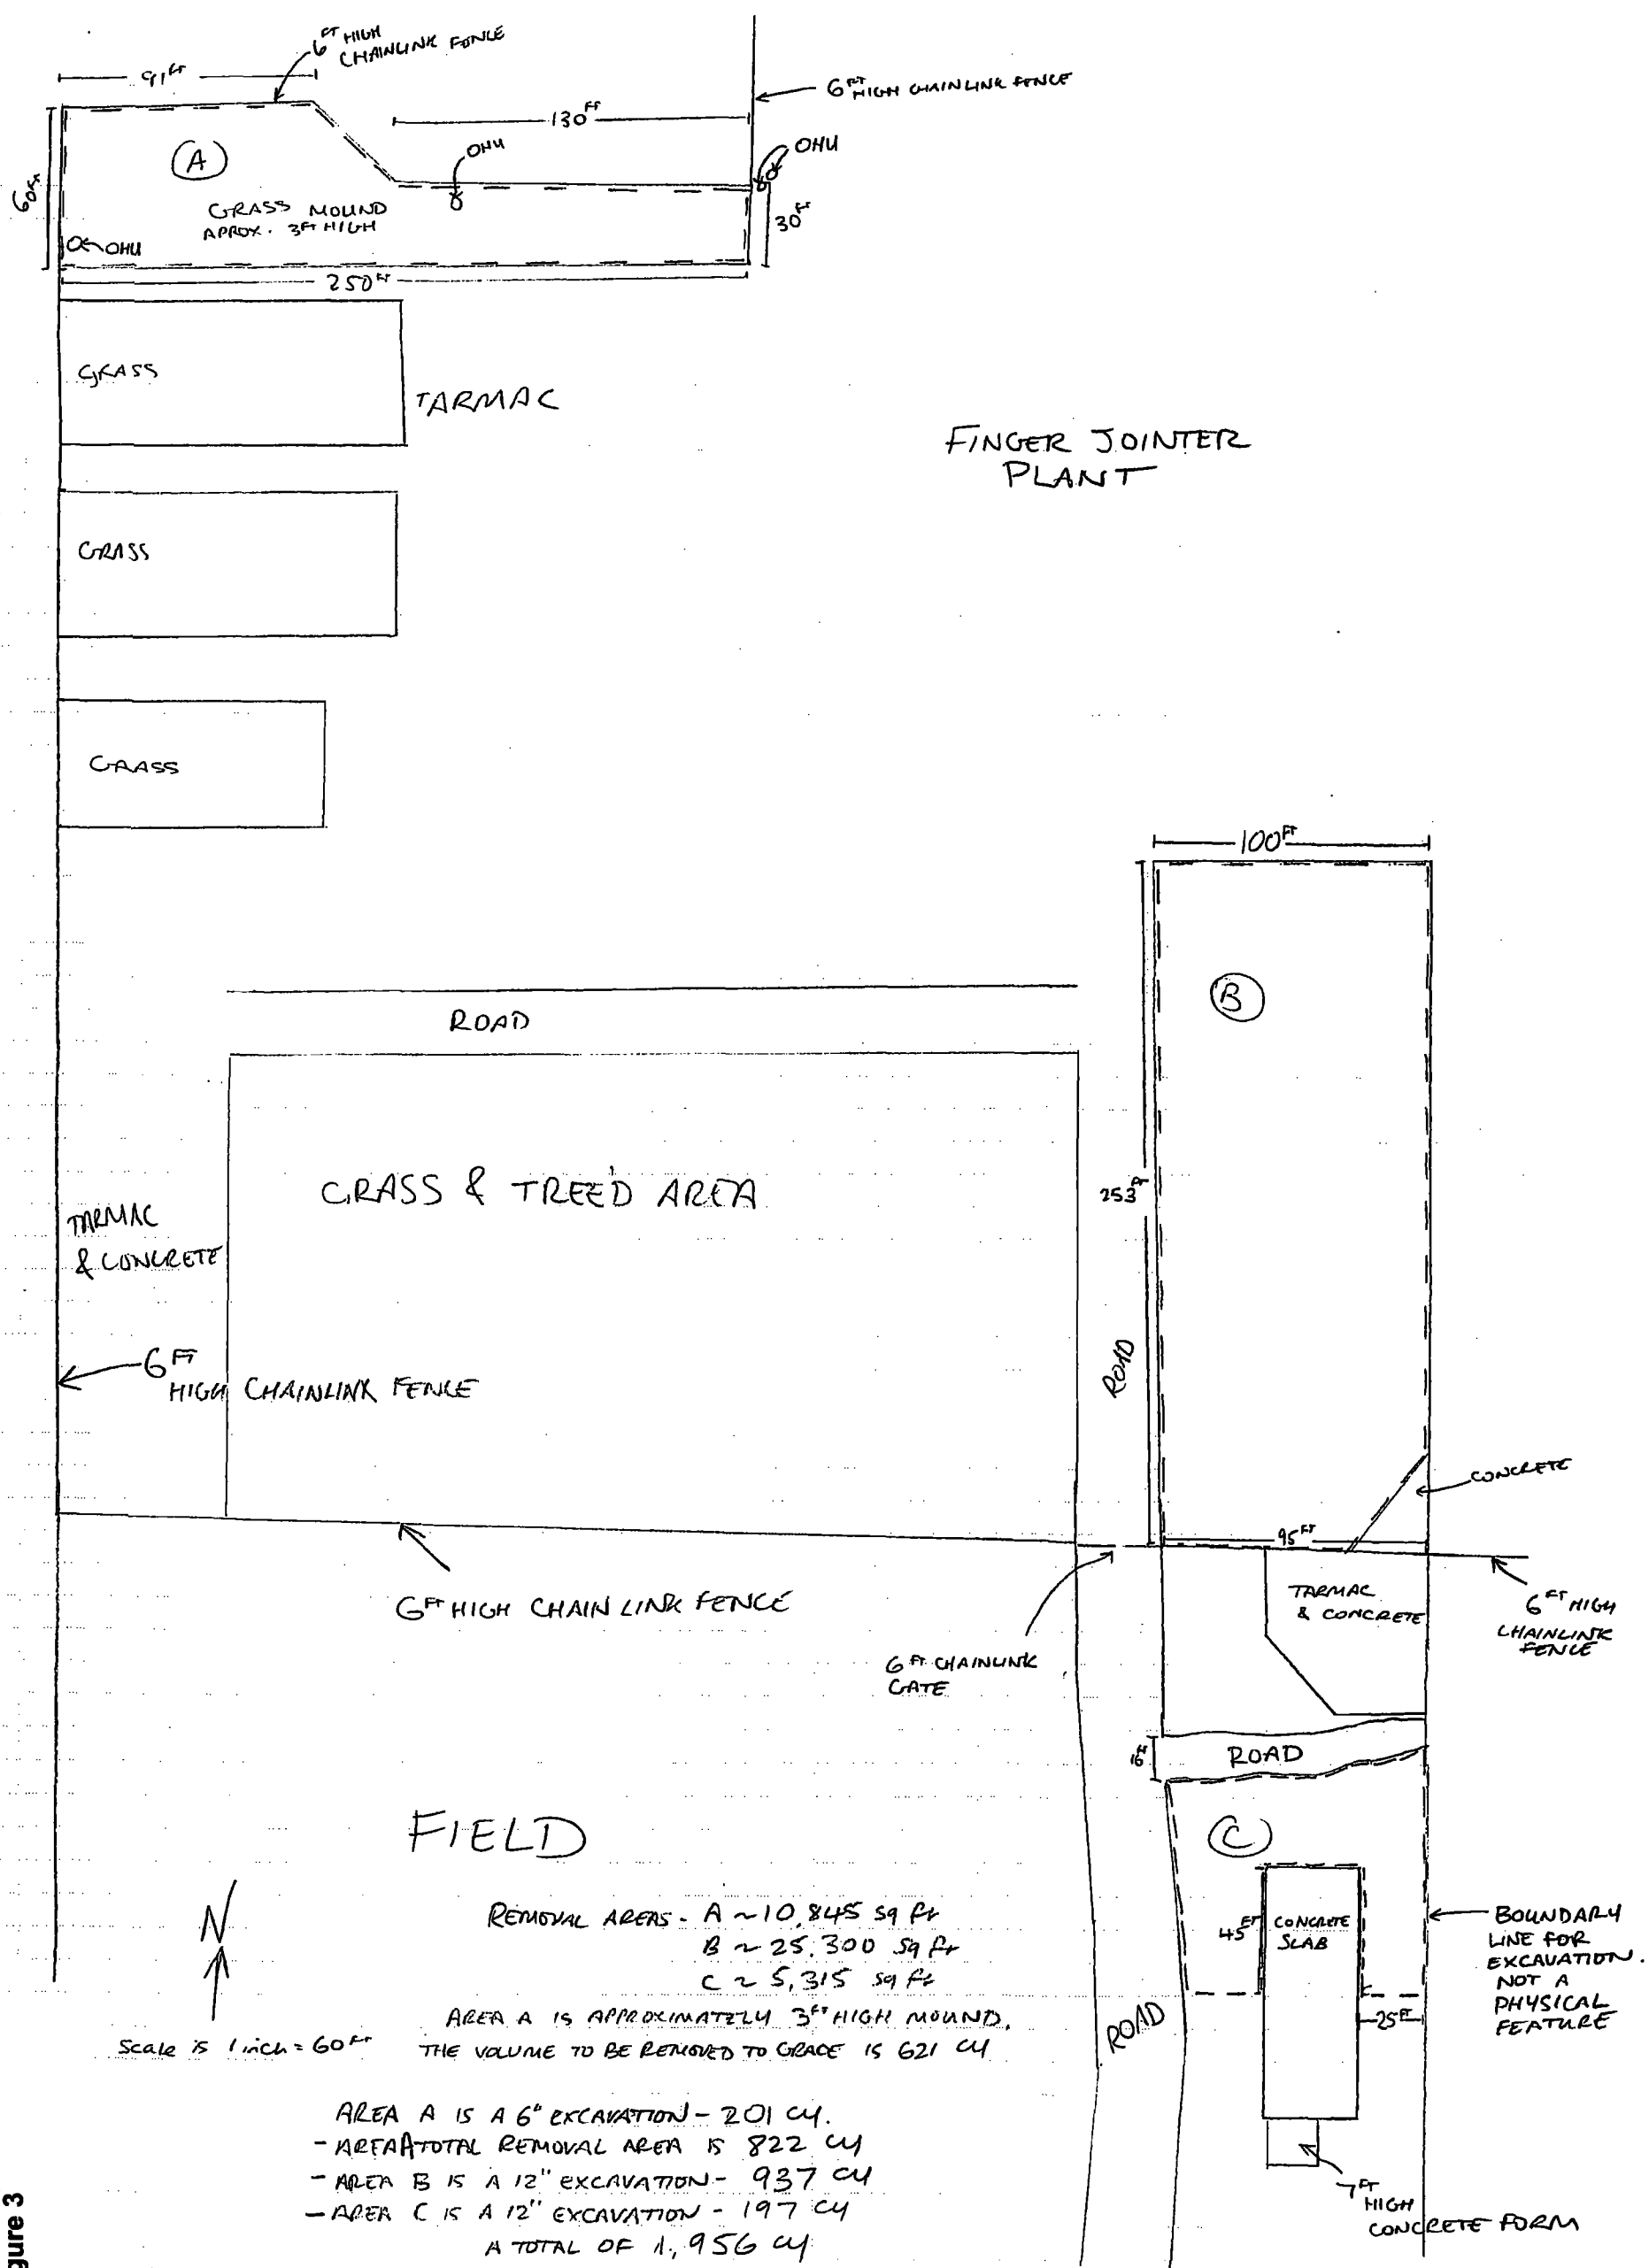
Areas requiring removal activities were identified based on results of this inspection and information gathered during previous investigations. In general, areas were identified for removal if vermiculite was observed and/or analytical results had detectable levels of LA. Figure 3 illustrates the areas requiring removal activities.

The total volume of material to remove is approximately 1,956 cubic yards. Area A, including mounded areas, will be excavated to 6 inches below surrounding grade. Areas B and C will be excavated to 12 inches below grade. Confirmation soil samples will be collected in accordance with the Response Action Sampling and Analysis Plan, Revision 1 (CDM 2008b). All areas will be restored with ¾-inch minus crushed rock (structural fill) to grade.
